NSWCCD-65-TR-2005/24 October 2005

### **Structural Irregularity and Damage Evaluation Routine (SIDER) for Testing of the 1/2-Scale Corvette Hull Section Subjected to UNDEX Testing**

Subj: SIDER NDE INSPECTION OF A 1/2-SCALE CORVETTE HULL SECTION

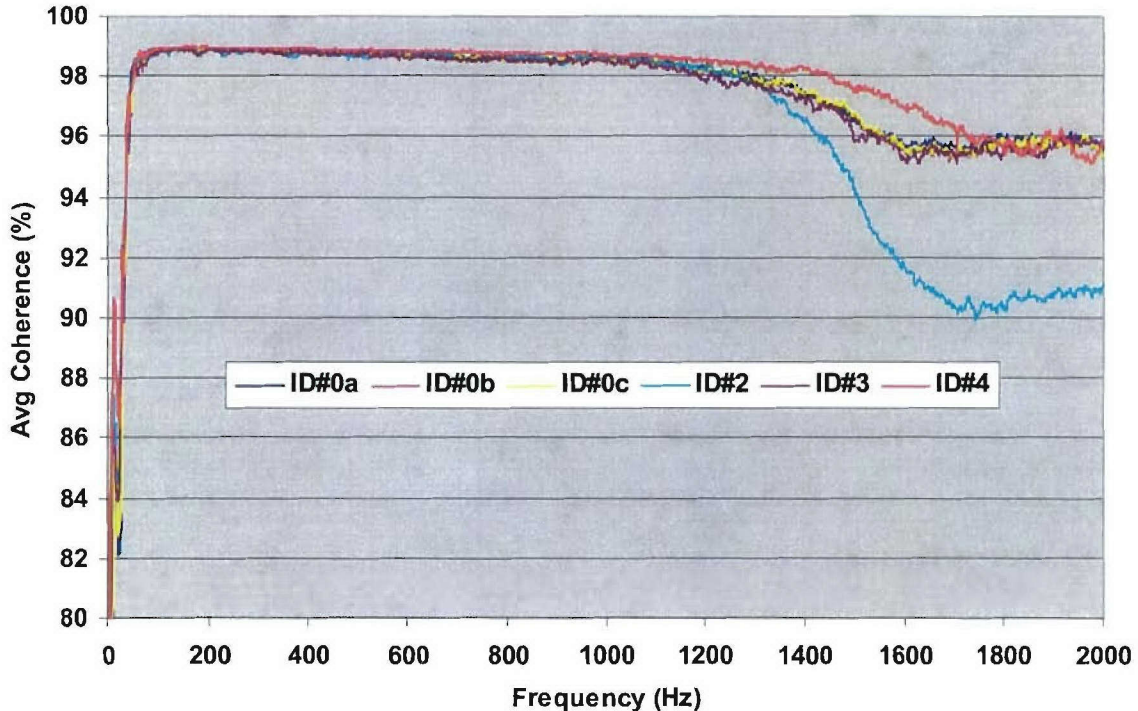
**Figure 6. Average Coherence**

The average coherence for all three baseline tests (ID#0a, ID#0b and ID#0c) and the data acquired after the third UNDEX (ID#3) are almost identical. For SIDER Test ID#2 (post UNDEX 2), the reduction in coherence above about 1400 Hz is directly attributable to the test environment. The hull was tested outside at Olpenitz and the wind was gusting. During SIDER testing each test point is impacted twice, and the resulting data are frequency averaged. The wind made it difficult to maintain the normal high level of repeatability typically achieved with the impulse excitation, resulting in a slightly reduced high frequency average coherence.

It is interesting to note that the average coherence for SIDER Test ID#4 (post 4<sup>th</sup> UNDEX) is the highest of all tests, showing that an increase in structural damage is not necessarily reflected in lower quality vibration data. The high coherence observed for this test is attributable to the test conditions. Both testers were well rested. Unlike some of the earlier tests, there was no sense of urgency and the weather was almost perfect – warm, overcast and calm.

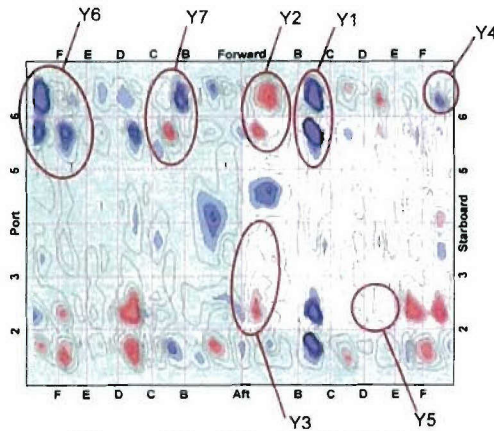
Figure 21. After UNDEX 3

### Feature Y2

Steady progress of localized structural change with increasing UNDEX. This is the location where the external ply buildup failed after UNDEX 3; see Figure 23.
